Western Run Pilot Project - Baltimore Maryland

Unique Test ID 263 Date: 10/7/2004 MeterBasin: 01_WR28
Observer ID: B Crew: T-2 Dye Test Recommended: N

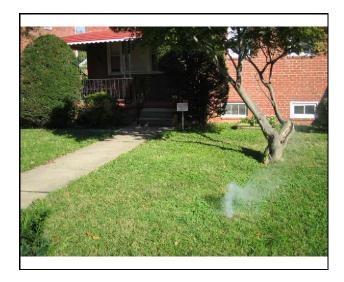
Photo No: 411

3926 Fallstaff ROAD

Source Type: 04= Cleanout **Location:** 7=Yard-Front **Severity:** 4=Major

Sector: 2=Private Drainage Area: 16

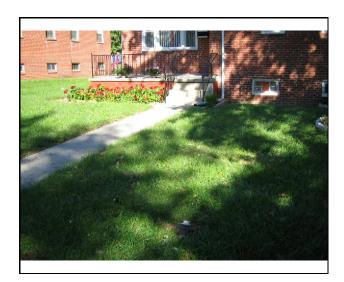
Photo No: 420

3914 Fallstaff ROAD

Source Type: 04= Cleanout **Location:** 7=Yard-Front **Severity:** 4=Major

Sector: 2=Private **Drainage Area:** 0

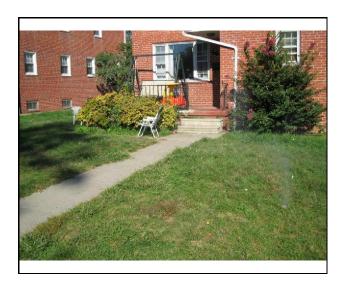
Photo No: 412

3906 Fallstaff ROAD

Source Type: 04= Cleanout **Location:** 7=Yard-Front **Severity:** 3=Moderate

Sector: 2=Private **Drainage Area:** 0

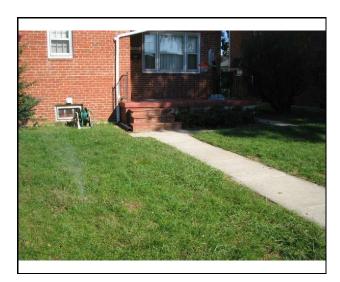
Photo No: 413

3904 Fallstaff ROAD

Source Type: 04= Cleanout **Location:** 7=Yard-Front **Severity:** 3=Moderate

Sector: 2=Private **Drainage Area:** 0

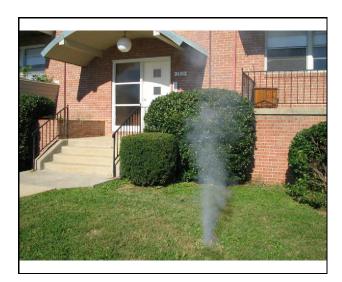
Photo No: 414

3810 Fallstaff ROAD

Source Type: 04= Cleanout **Location:** 7=Yard-Front **Severity:** 4=Major

Sector: 2=Private Drainage Area: 4

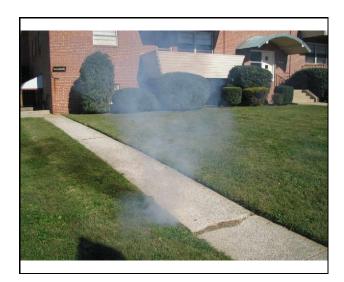
Photo No: 415

3806 Fallstaff ROAD

Source Type: 04= Cleanout **Location:** 7=Yard-Front **Severity:** 4=Major

Sector: 2=Private Drainage Area: 40

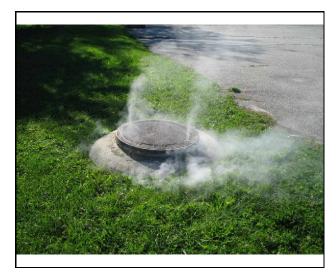
Photo No: 419

House Number Street Prefix: Street Name: Street Type: 3801 Fallstaff ROAD

Source Type: 12= MH Frame Seal **Location:** 7=Yard-Front **Severity:** 4=Major

Sector: 1=Public Drainage Area: 16

Comments: MH 1521334

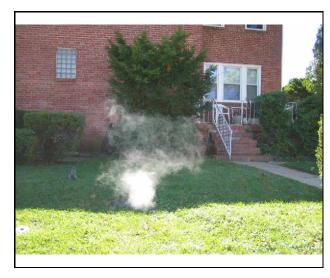
Photo No: 421

3829 Labyrinth ROAD

Source Type: 04= Cleanout **Location:** 7=Yard-Front **Severity:** 4=Major

Sector: 2=Private **Drainage Area:** 0

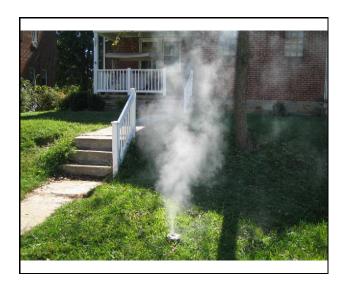
Photo No: 422

3807 Labyrinth ROAD

Source Type: 04= Cleanout **Location:** 7=Yard-Front **Severity:** 4=Major

Sector: 2=Private **Drainage Area:** 0

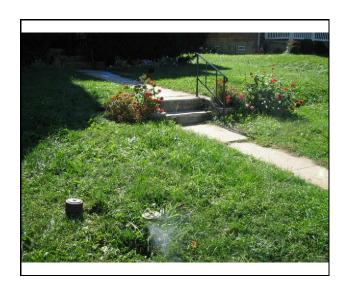
Photo No: 423

3805 Labyrinth ROAD

Source Type: 04= Cleanout **Location:** 7=Yard-Front **Severity:** 4=Major

Sector: 2=Private **Drainage Area:** 0

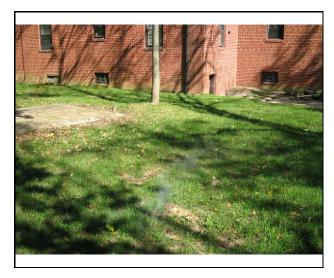
Photo No: 425

3703 Fallstaff ROAD

Source Type: 04= Cleanout **Location:** 8=Yard-Back **Severity:** 3=Moderate

Sector: 2=Private **Drainage Area:** 0

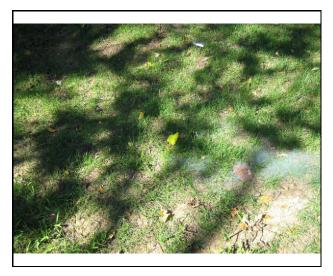
Photo No: 426

3703 Fallstaff ROAD

Source Type: 02= Service Line **Location:** 8=Yard-Back **Severity:** 2=Trace

Sector: 2=Private Drainage Area: 20

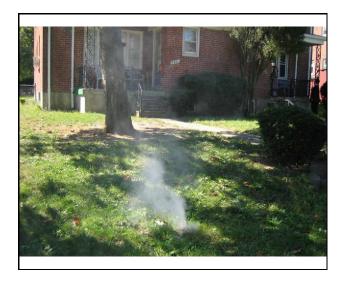
Photo No: 427

6800 Williamson AVE

Source Type: 04= Cleanout **Location:** 7=Yard-Front **Severity:** 4=Major

Sector: 2=Private **Drainage Area:** 0

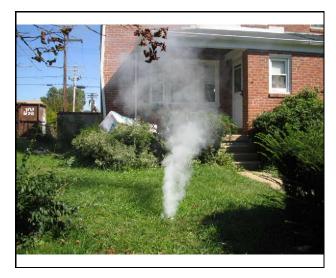
Photo No: 428

6807 Williamson AVE

Source Type: 04= Cleanout **Location:** 7=Yard-Front **Severity:** 4=Major

Sector: 2=Private **Drainage Area:** 0

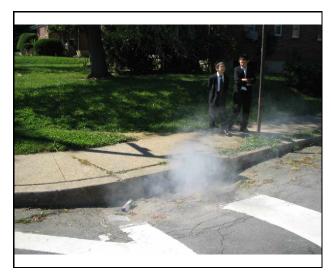
Photo No: 429

3700 Labyrinth ROAD

Source Type: 14= Catch Basin **Location:** 7=Yard-Front **Severity:** 4=Major

Sector: 1=Public Drainage Area: 10000

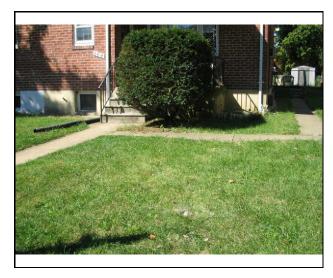
Photo No: 430

3618 Labyrinth ROAD

Source Type: 04= Cleanout **Location:** 7=Yard-Front **Severity:** 3=Moderate

Sector: 2=Private **Drainage Area:** 0

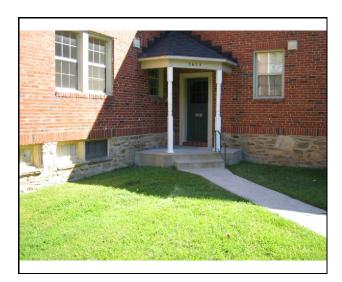
Photo No: 431

3605 Labyrinth ROAD

Source Type: 04= Cleanout **Location:** 7=Yard-Front **Severity:** 3=Moderate

Sector: 2=Private **Drainage Area:** 0

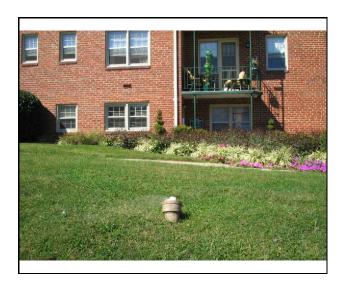
Photo No: 432

3600 Labyrinth ROAD

Source Type: 04= Cleanout **Location:** 7=Yard-Front **Severity:** 3=Moderate

Sector: 2=Private **Drainage Area:** 0

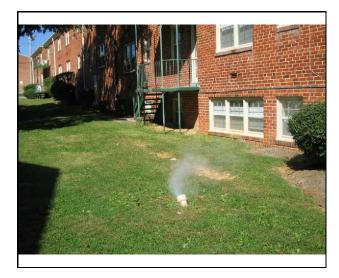
Photo No: 433

3600 Labyrinth ROAD

Source Type: 04= Cleanout **Location:** 7=Yard-Front **Severity:** 4=Major

Sector: 2=Private **Drainage Area:** 0
